AUDIT REPORT

Safety provisions for United Nations staff and contractors, including asbestos removal, applied during the execution of the Capital Master Plan

28 January 2011
Assignment No. AC2010/514/01

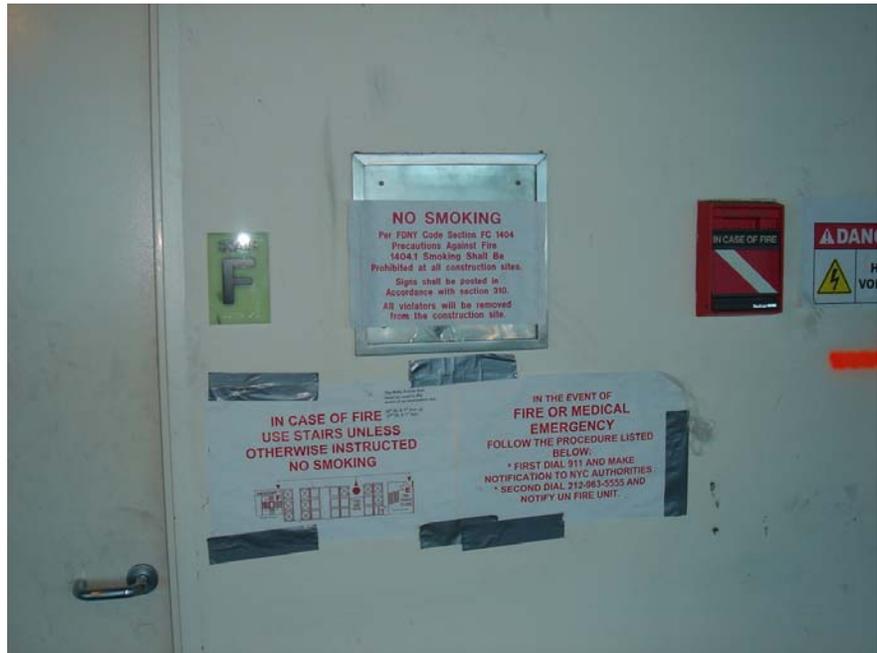
- (a) Random badge checks were carried out and found to be correct.
- (b) Personal protection equipment was correctly worn and displayed the identity of the contractor.
- (c) Signage was prominently displayed in all construction areas, including exits, evacuation details, emergency contacts and the requirement to wear personal protection equipment.

Photo 1 – Signage at the construction site

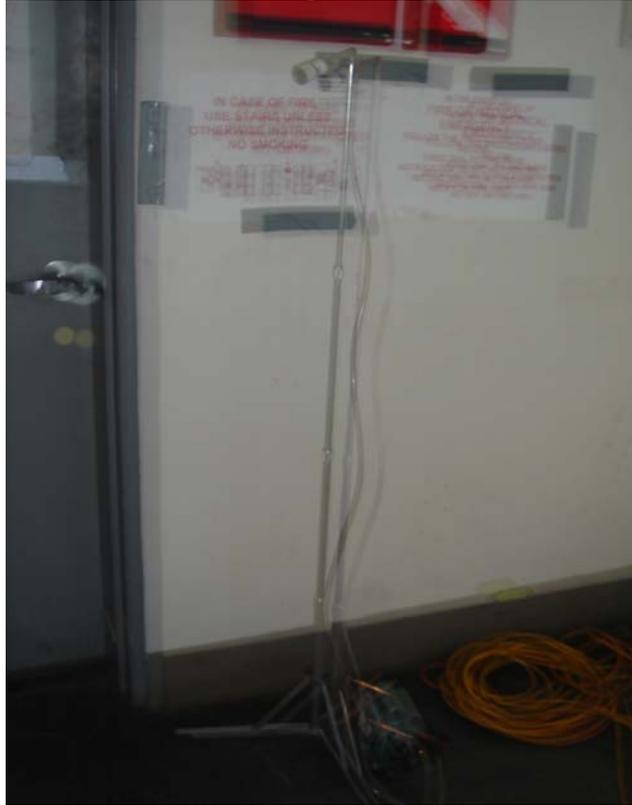
Photo 2 – Air monitoring machine

50. Air monitoring was carried out by one of two firms who were independent of both the construction manager and the contractor carrying out the asbestos abatement. Monitoring machines checked the concentration of asbestos fibres in the air, which must be less than 0.01 fibres per cubic centimeter of air. Air monitoring was carried out prior to, during and after abatement works and testing results were emailed to the member of staff of the consultant programme manager who oversees and coordinates abatement works. Written results were also submitted, including re-occupancy letters from the air monitors that confirm compliance with regulatory requirements and clear the specified area for re-occupancy. The consultant programme manager's staff stated that no results received from the air monitors exceeded the maximum allowed since abatement works began. This was confirmed by OIOS checks on all the re-occupancy letters for 2010 (up to 27 July 2010) which were usually issued within a day of abatement work being completed.

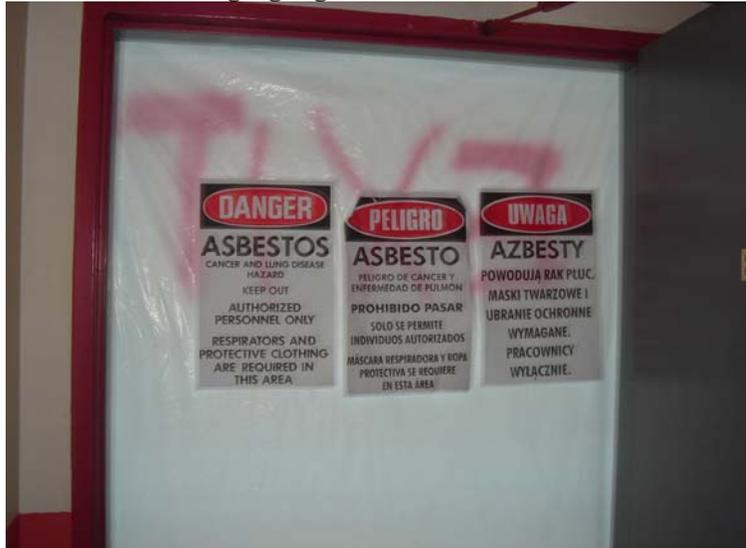
Photo 3 – Warning signage

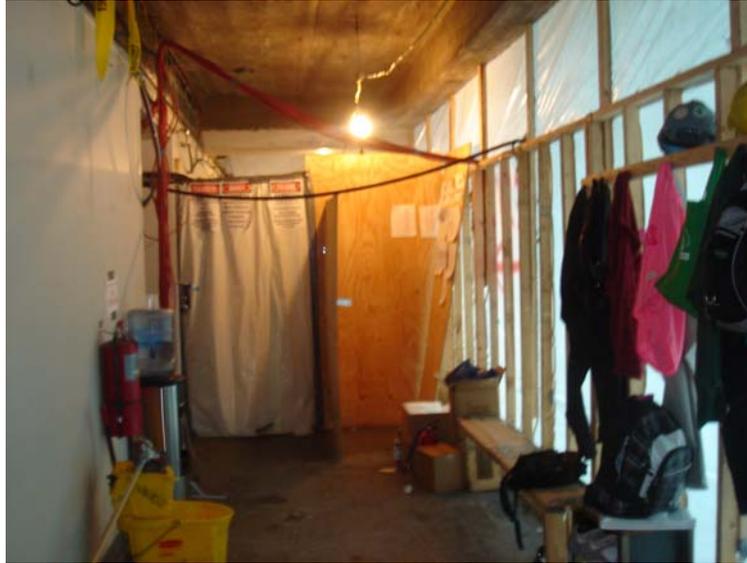
Photo 4 – Changing area
